2 MOTOR GRADER TEST

Warco Grader - Model 4D-100,

San Bernardino and Angeles National Forests

January 17 - February 8, 1951 //

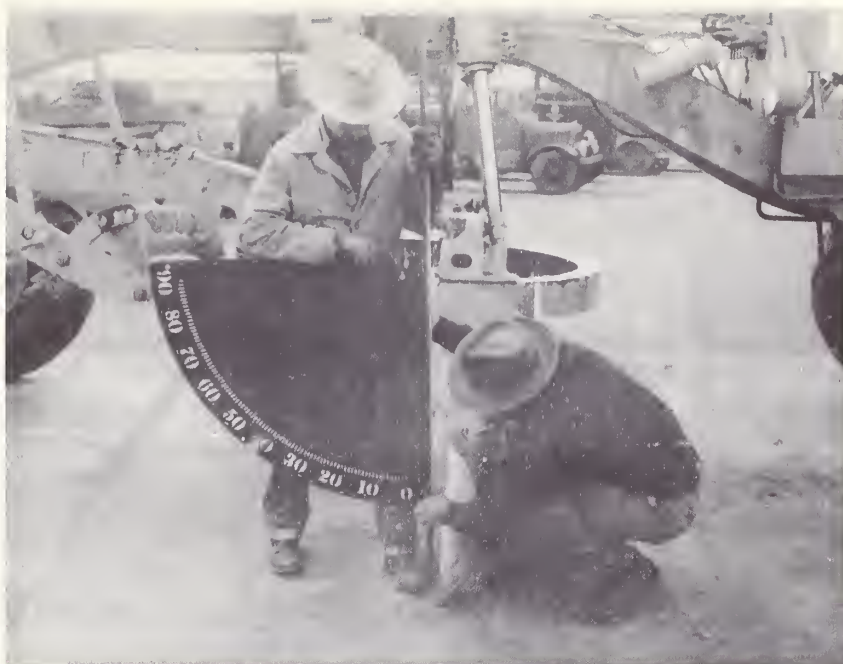
Fig. 8. $+11\frac{1}{2}^{\circ}$ Pitch Position

It was the opinion of operators and observers that under some conditions better blade operation might be had if the top of the blade could be tilted further to the rear of the grader. In an attempt to do this, it was found that at an angle of $\pm 11\frac{1}{2}^{\circ}$, see Figure 8, the blade hit against the drawbar where shown in Figure 9.

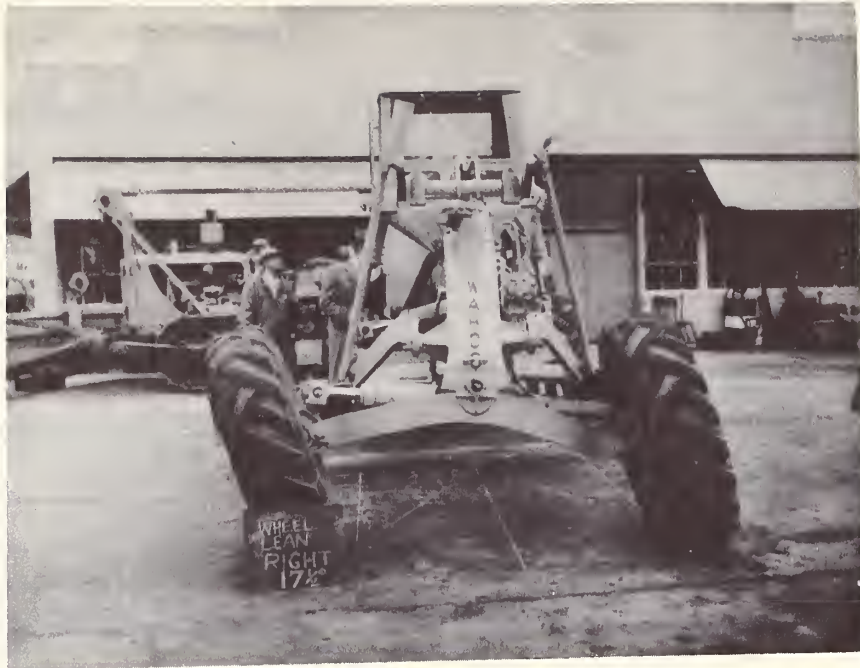
Fig. 10. Maximum Wheel Lean

The wheel lean was less than specification requirements, as well as below that of any other acceptable machine tested. Because of this condition particular attention was paid to side shifting of the machine under heavy loadings, especially in the ditching operation. The machine was not considered as stable as two of the other machines, but was considered acceptable. It is the consensus of observers, however, that the wheel lean of the Warco is at the minimum that could be considered as effective for normal operation. Any decrease of the front end weight, without increase of the angle of wheel lean, would possibly be detrimental to normal operation. An analysis of the construction indicates that, with slight alteration, it would be possible to obtain an increase in wheel lean.

Opinions of the three operators who handled the machine during the tests revealed that they had no difficulty that could be attributed to deficiency of wheel lean. Figure 10 shows the maximum wheel lean of the Warco grader.

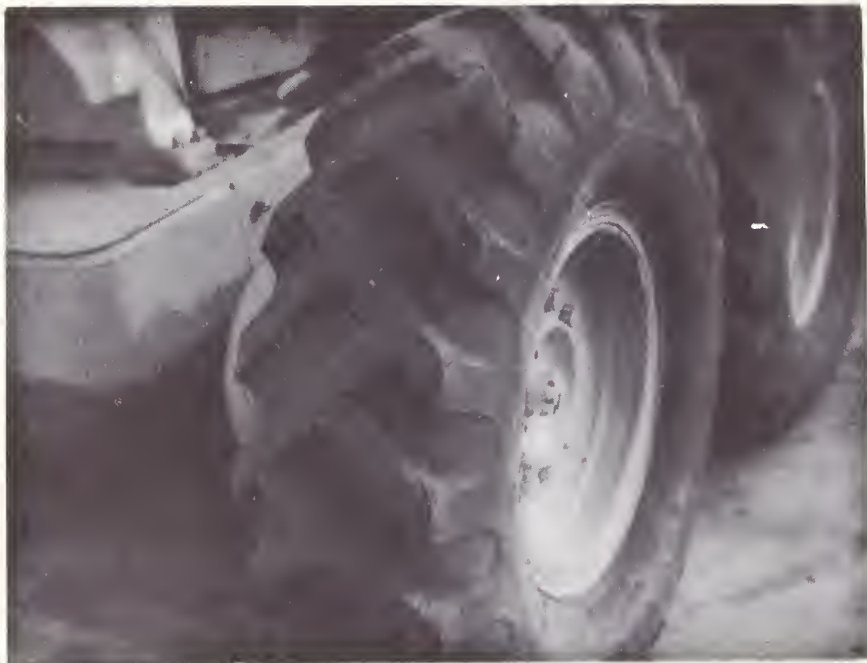
Fig. 11. Tire Condition

Tires, as furnished, were Firestone 14:00 x 24, 8 ply lowpressure nylon cord type. Final inspection on completion of test showed tires to be in very good condition. Figure 11 shows the worst cuts on any of the tires after the test period.

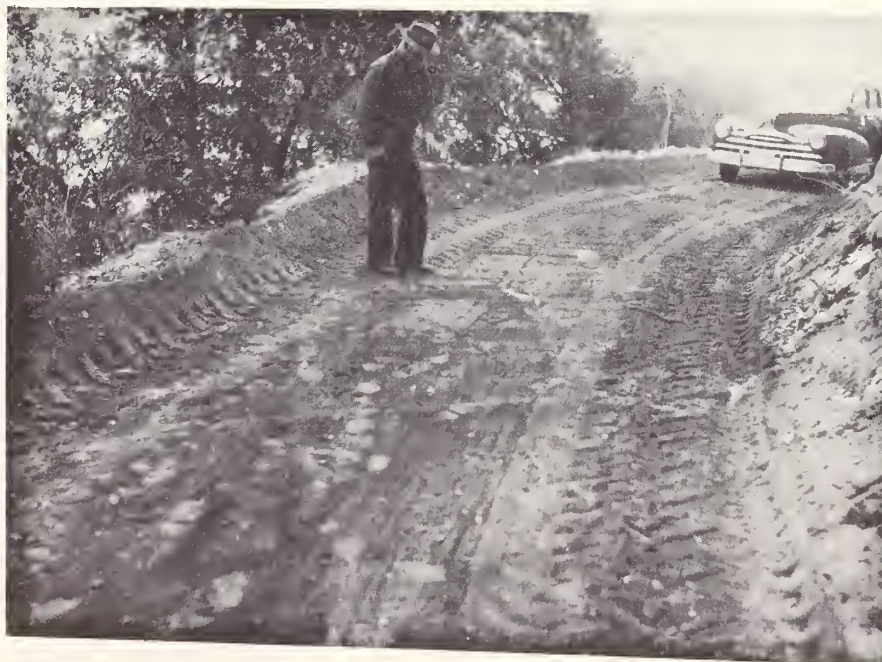
Fig. 12. Ridges caused by rock obstructions

One of the disadvantages of the low pressure tires was a tendency of the machine to bounce several times after the blade passed over an obstruction, causing a series of ridges. Photograph No. 12 shows two series of ridges caused by two rocks imbedded in the surface. This difficulty, however, was not judged to be of a serious nature.

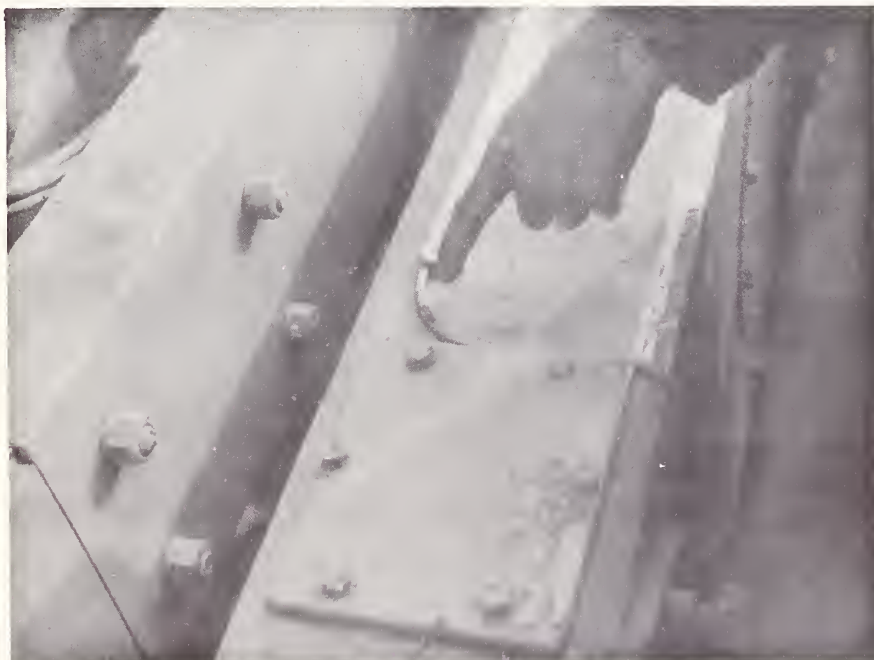
Fig. 14. Damaged Brakeline Tubing

Photograph, Figure 14, shows an unprotected section of hydraulic brake line tubing across the tandem housing.

The lines on both sides of the machine were damaged as shown. One line was damaged before machine had been removed from the flat car on which it was shipped to Arcadia. The other was damaged by being stepped on by the operator while servicing machine. It is felt that protection similar to that given the lines along the length of the tandem is desirable at this point.

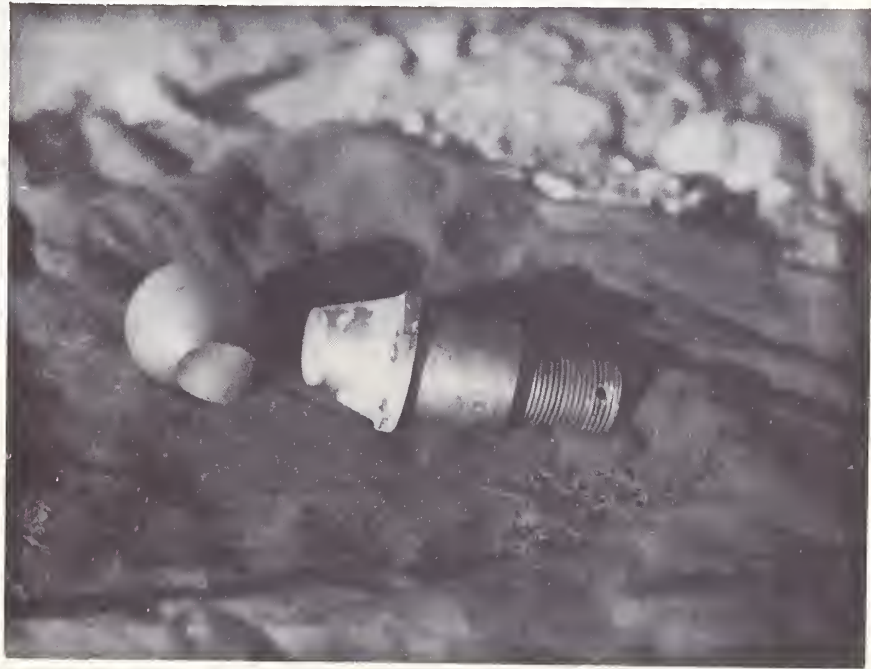
Fig. 15. Stud Ball Failure

In terms of breakdowns that rendered the machine inoperable, there were two breaks of the stud ball that connects the pitman arm to the Garrison steering booster control valve. Photograph, Figure 15, shows the nature of the break.

The breakdown pictured, occurred twice during the ditching operation when the wheels were leaned to the left and sharply turned left. If, in this setting, the machine was in such position that the left wheel was at its lowest point as controlled by the stop on the front of the machine, sufficient bind was put on the Garrison cylinder to break the stud ball. Redesign of this assembly connection would eliminate this source of difficulty.

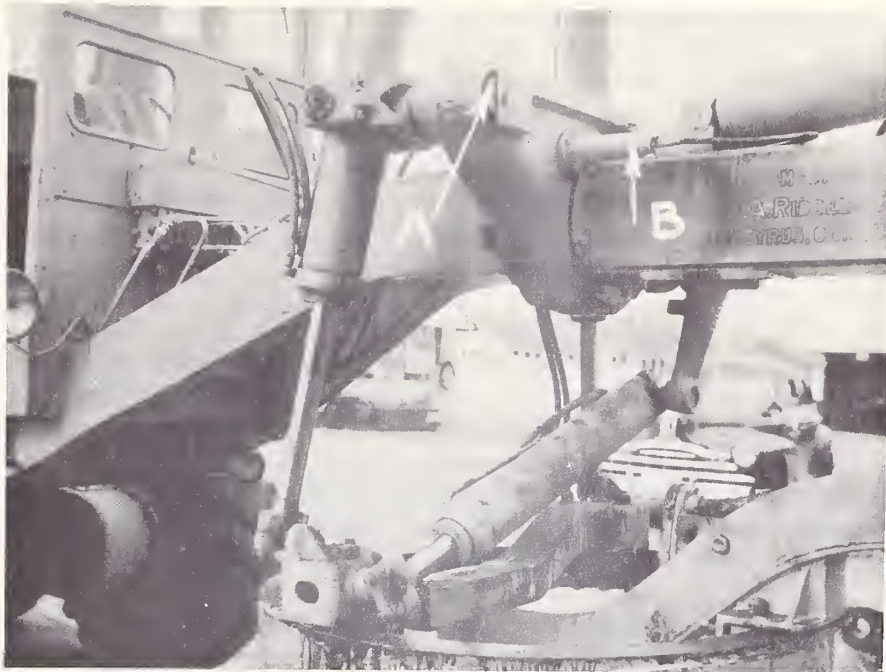
Fig. 17. Saddle Assembly

In Fig. 17 arrow A points to the lift arm pivot bearing of the saddle casting. Looseness of this bearing, particularly on the right side of the machine, was noticeable. Since no means of adjustment was provided, the adequacy of this bearing was questioned.

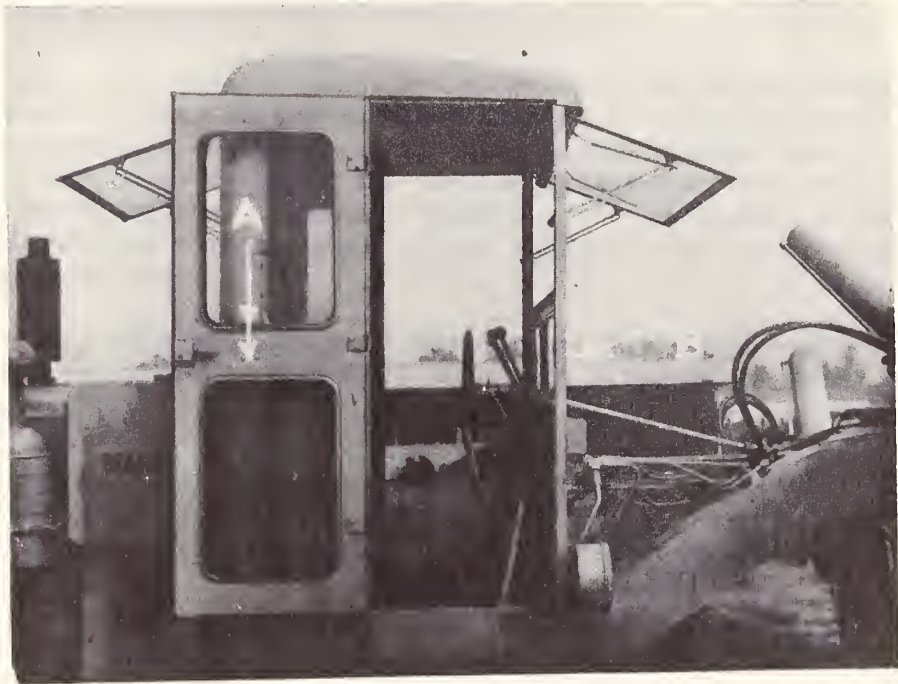
Fig. 20. Cab Side View

In Fig. 20, arrow A points to the location of the latch meant to hold the cab door open during operation. These ~~were~~ were not sufficiently strong and should be replaced with a more suitable type.

Arrow B shows the approximate point at which a grab iron for use of operator in getting into cab should be installed.

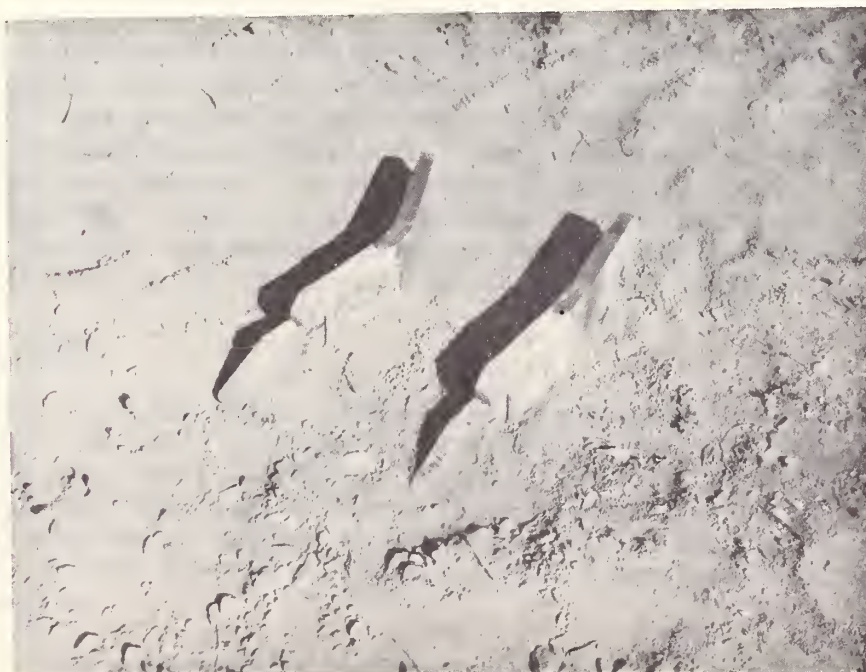
Fig. 26. Bent Scarifier Teeth

The work of scarifying was satisfactory and comparable to the operation of other machines tested. However, tooth base stock of the Warco was thought to be softer than that of other machines tested, since bending during tests was experienced. Photograph, Figure 26, shows condition of scarifier teeth after 20 minutes of operation at the ditching site.
